## Monitoring and Legacy Report

## Derby PSiCA

The benefits of heritage led regeneration

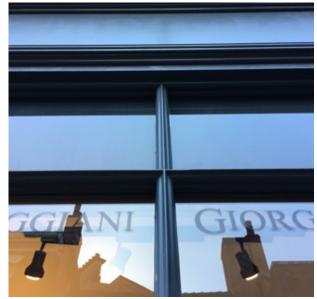
28 Sadler Gate: The project officer worked closely with the contractor to ensure a high quality 'lamb's tongue' finish to the glazing bars.

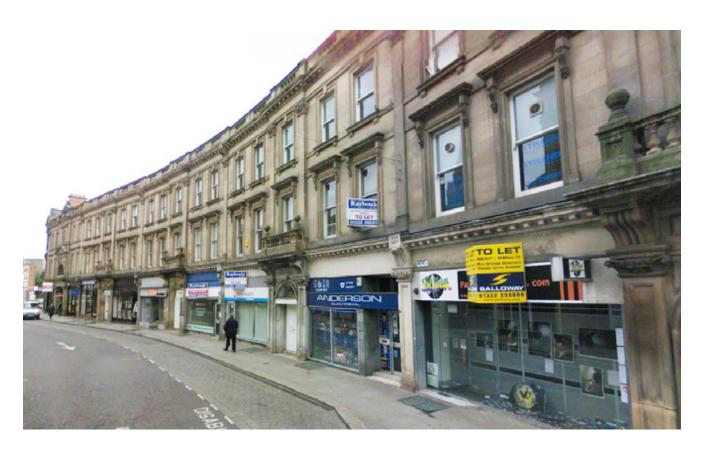
10 - 28 The Strand, Derby prior to multiple shop front repairs and reinstatement

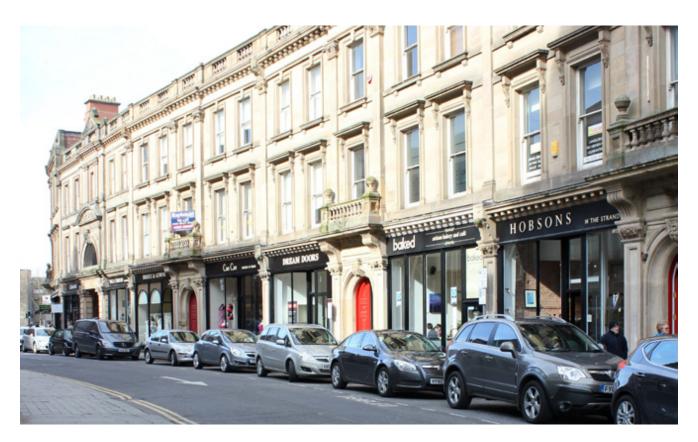
10 - 28 The Strand, Derby following multiple shop front repairs and reinstatement

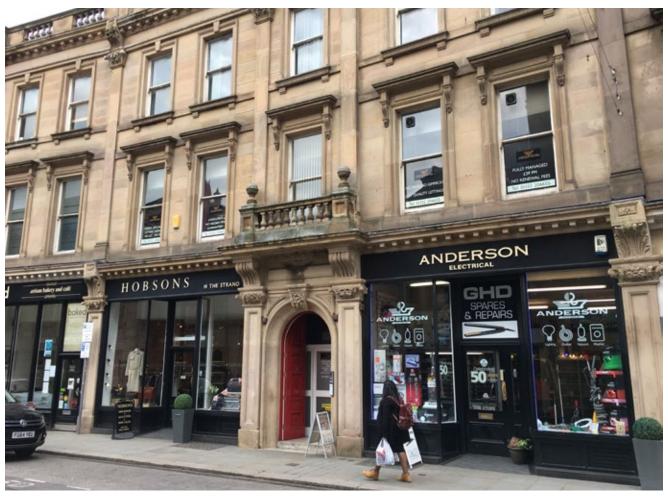
Newly repaired and reinstated shop fronts and doorway to No. 10, 12 & 14 The Strand

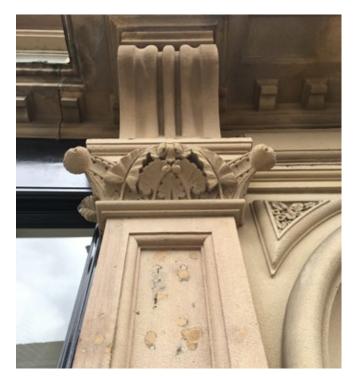
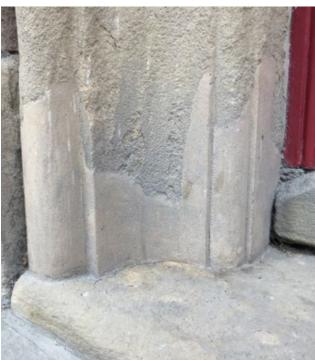
Details of repaired stone works

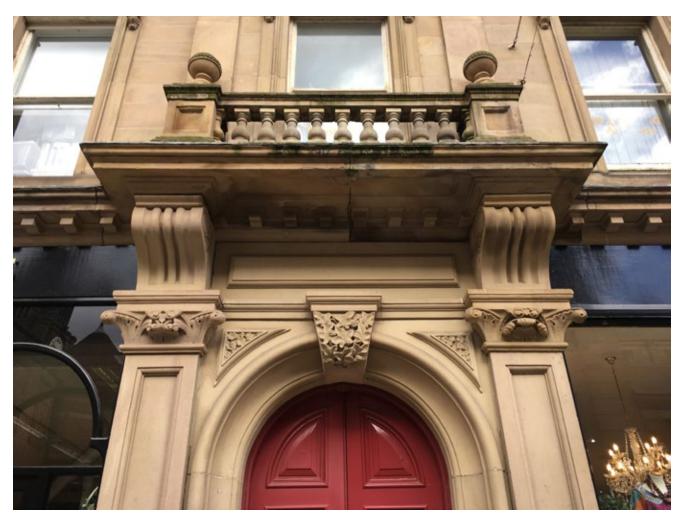
Details of repaired stone works to entrance door way columns and arch

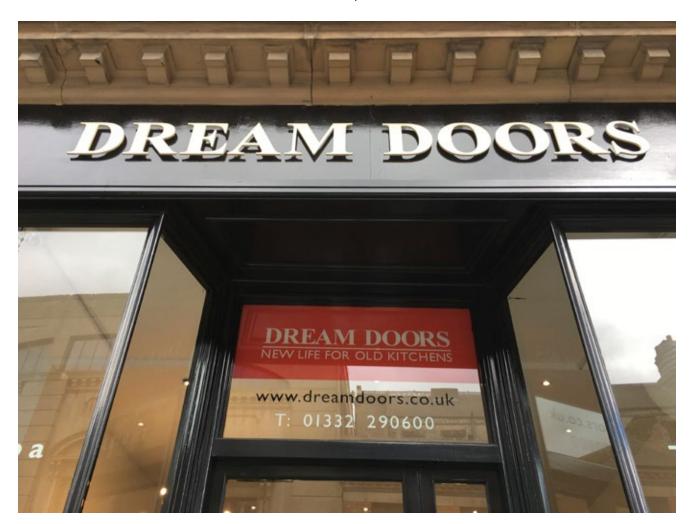
Details of the fascia and individual lettering signage, soffit, corner post and door frame

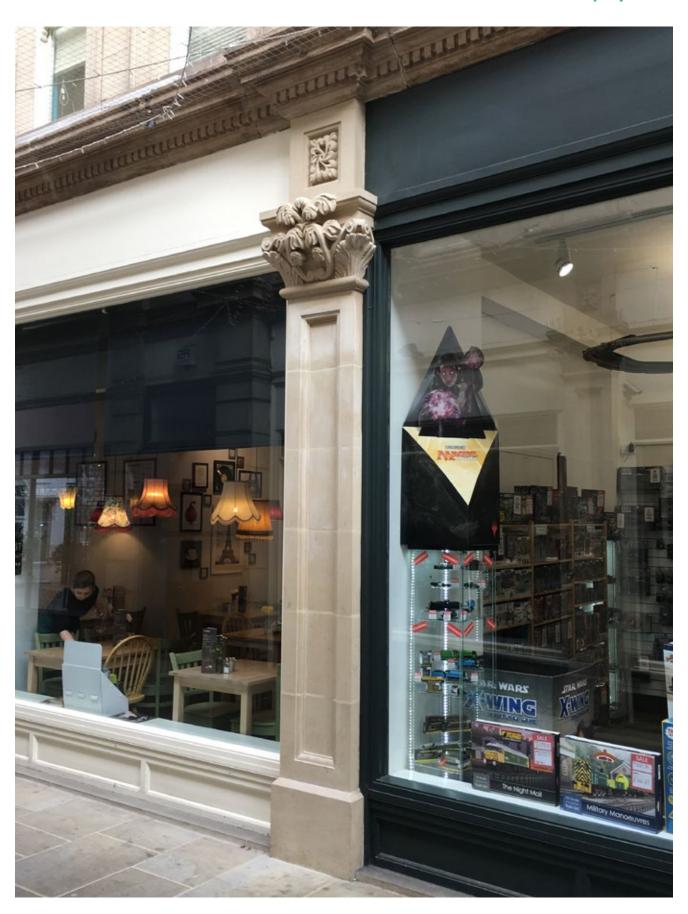
Details of the reinstated pilaster and carved capital between No. 4 & 5 The Strand Arcade

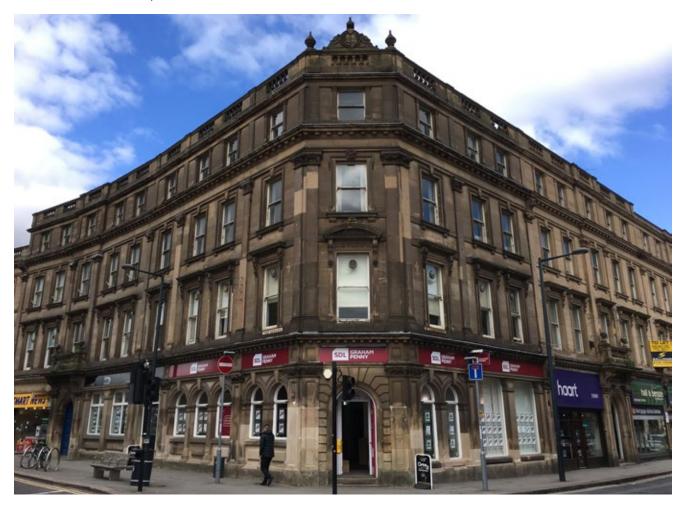
# 2-6 THE STRAND, DERBY

**Heritage Need:** Stonework in poor state of repair.

**Scope of work:** Stonework repairs and reinstatement

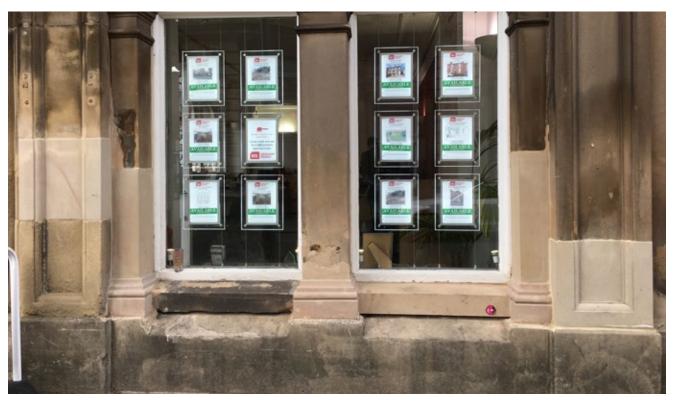
Details of repaired stoneworks with reinstated missing features of columns and cill

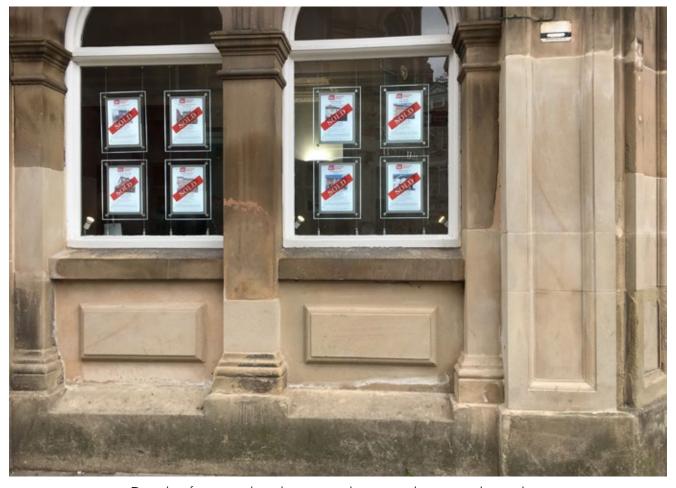
Details of repaired and reinstated stone columns and paneling

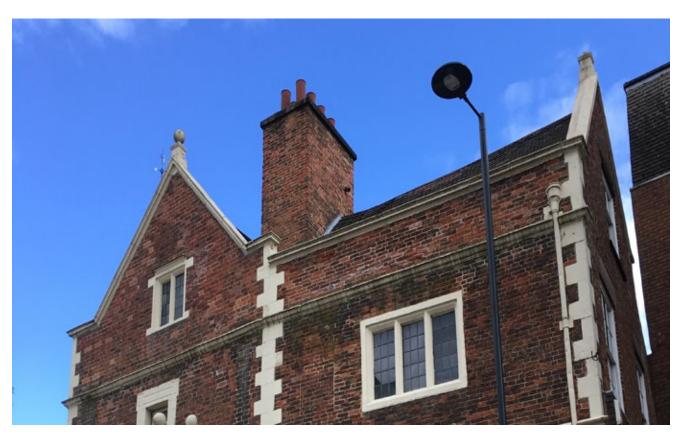
Newly repaired roof and chimney stack from side elevation

**Scope of work:** Repair of sash windows, roof, two chimney stacks,

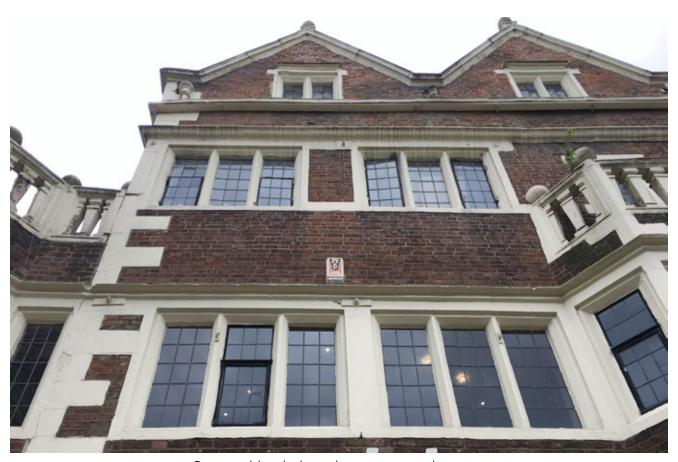
Repaired leaded windows to main elevation

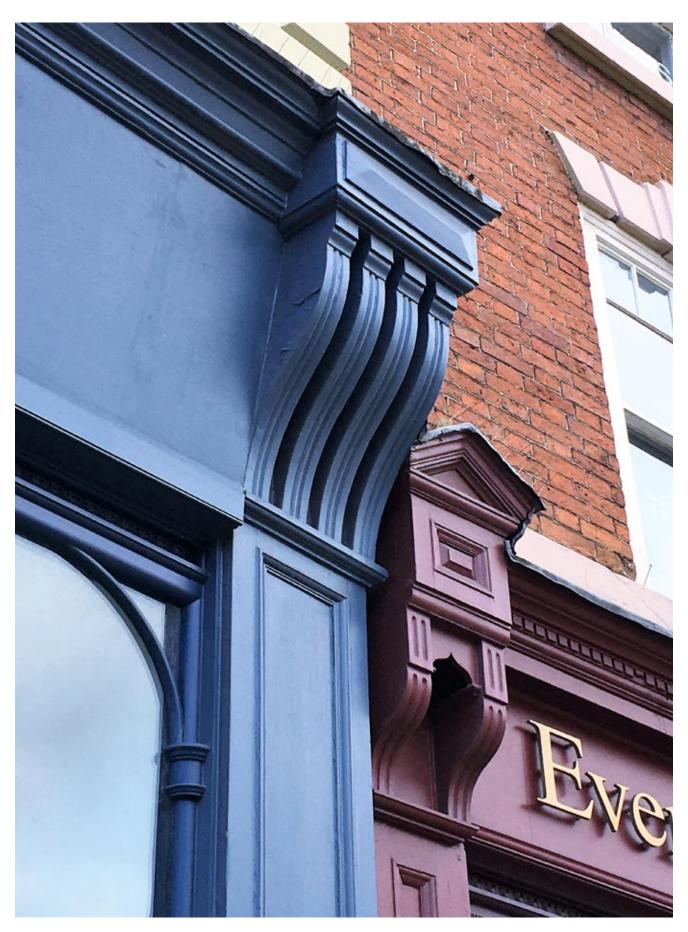
Details of timber moulded bracket, cornice

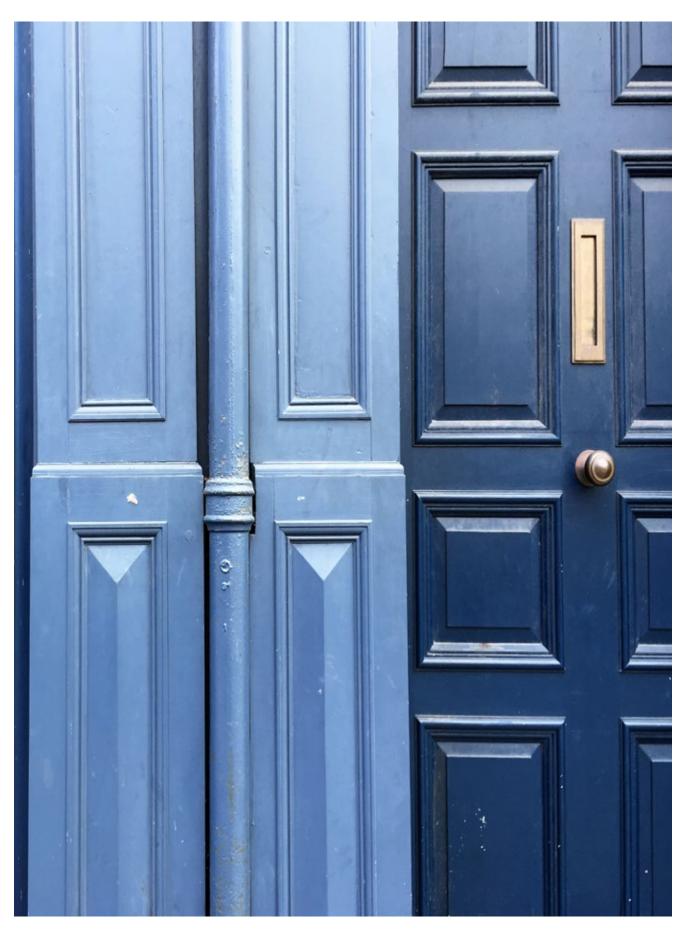
Moulding details of the pilasters and door paneling with broze metal ironmongery details

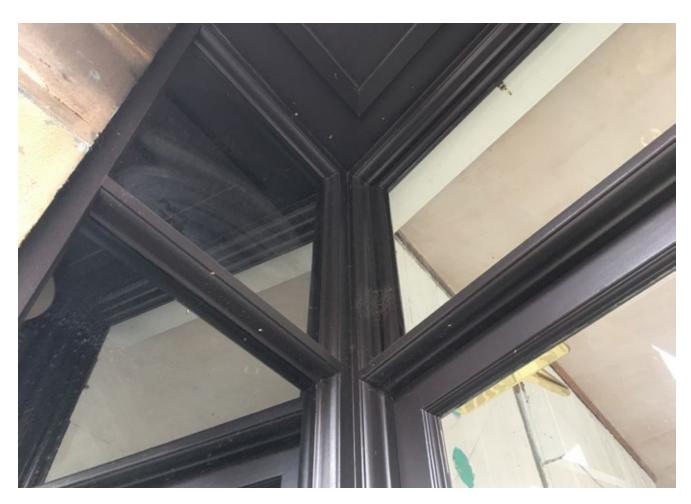
Details of shop front recess moulded framing to door, window, fanlight and side paneling

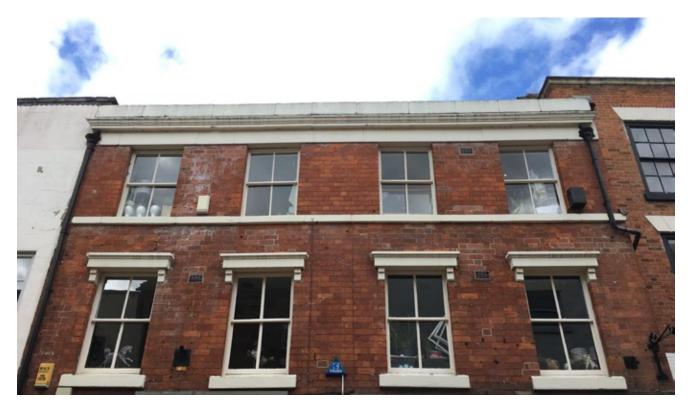
Repaired roof and upper floor elevation

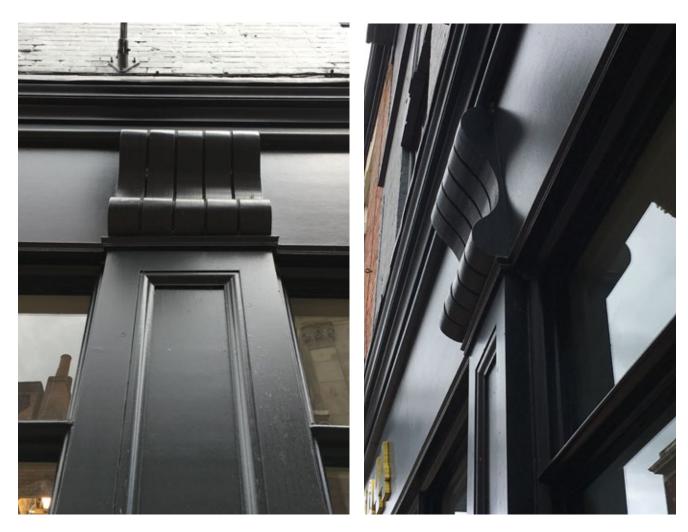
Detail of the timber moulded bracket and pilaster

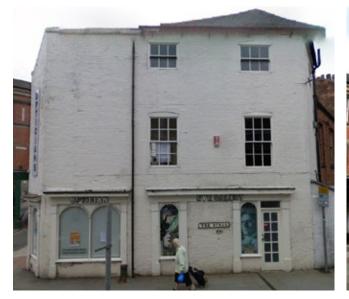
Before and after repairs and reinstatement of the historic shop front elevation towards The Strand

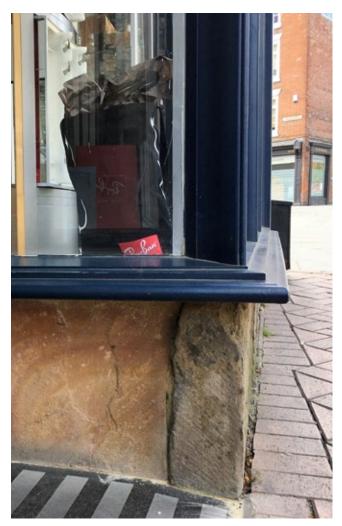
Details of the original stone stall riser, moulded bull nose with corner post

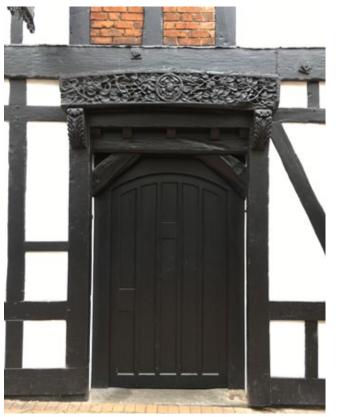
Newly reinstated door to the bar with repaired decorative lintel details

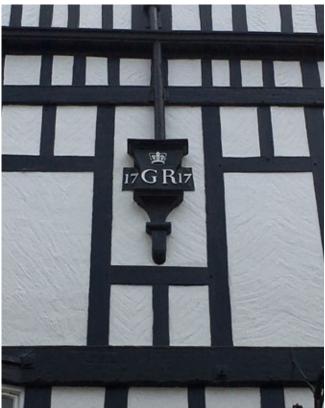
Detail of repaired frontage

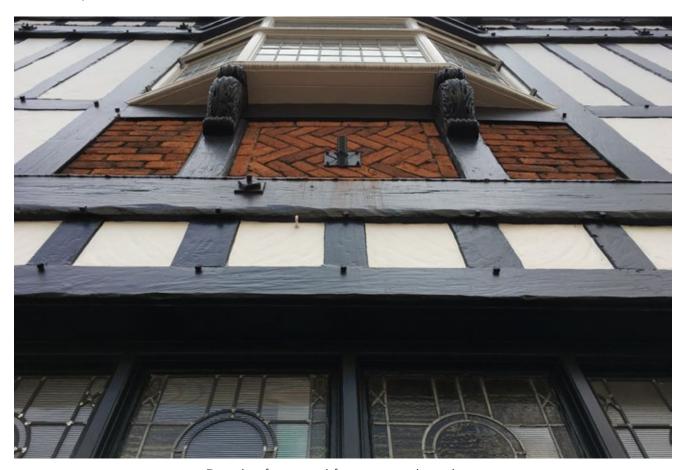
Details of repaired frontage and windows

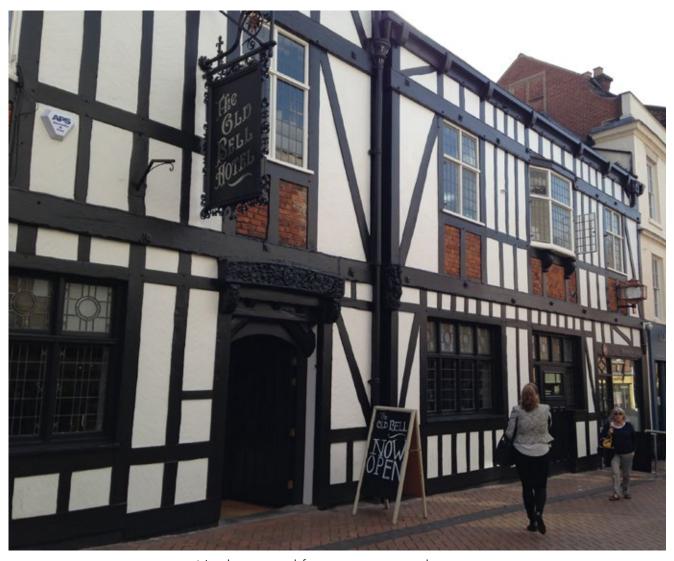
Newly repaired frontage to main elevation

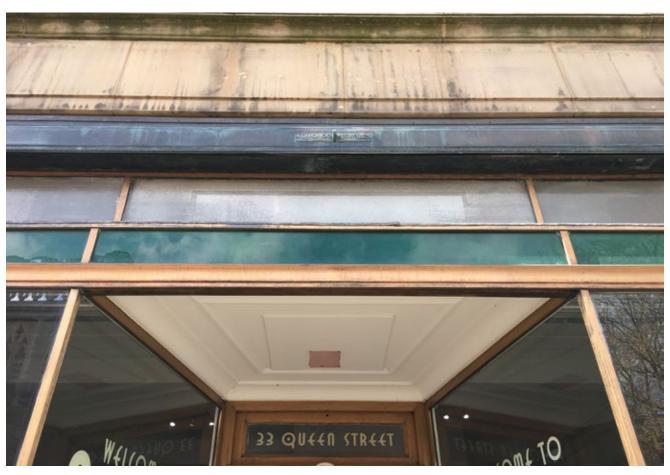
Details to shop front recess soffit with timber moulded panel, cleaned and repaired bronze shop front frame and awning box above

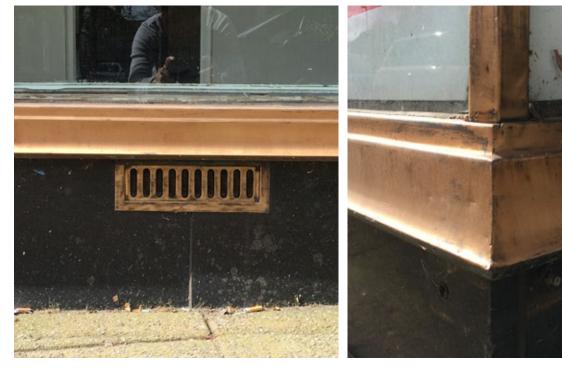
Details of cleaned and repaired bronze metal shop front frame at sill, black granite and bronze vent grille to stall riser and corner post

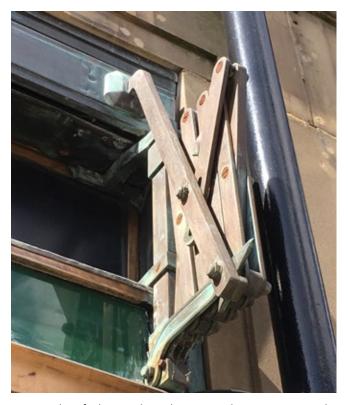
Details of cleaned and repaired awning metal scissor

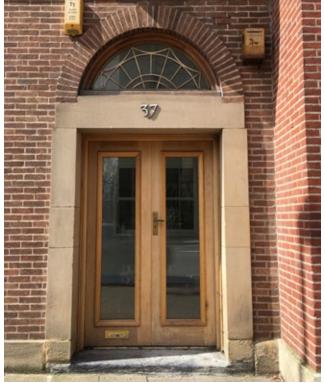
Reinstated oak door with bronze metal ironmongery details

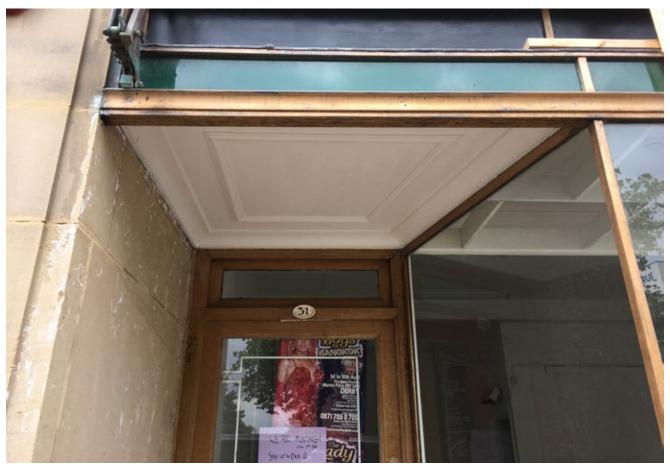
Details of recess soffit and side stone works, cleaned and repaired bronze metal cornice and corner post

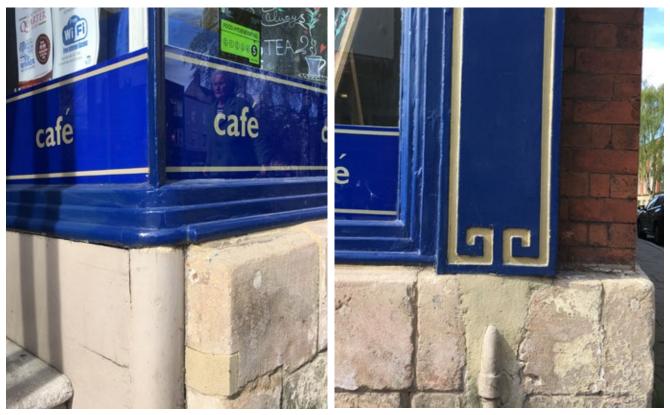
Details of repaired stone plinth

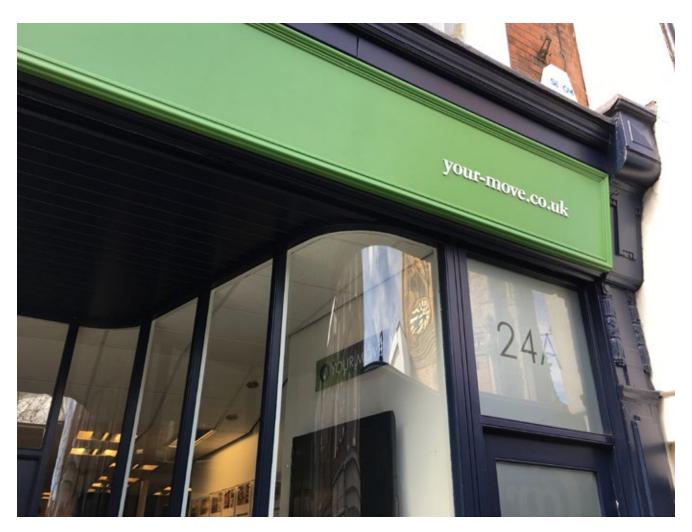
Curved corner details to recess

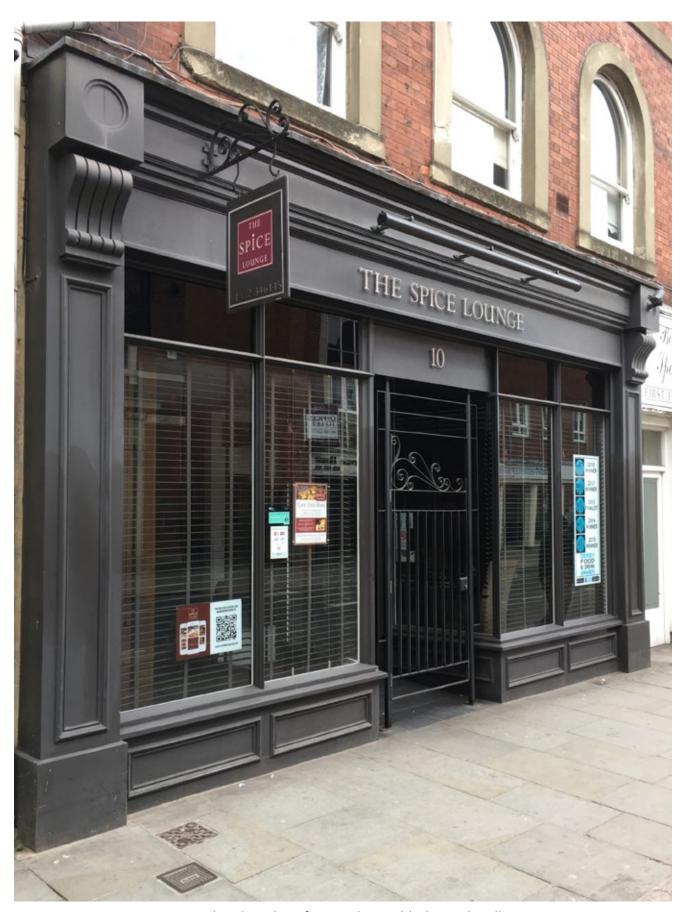
Reinstated timber shop front with moulded panel stall riser, cast iron decorative hanging sign and a security gate

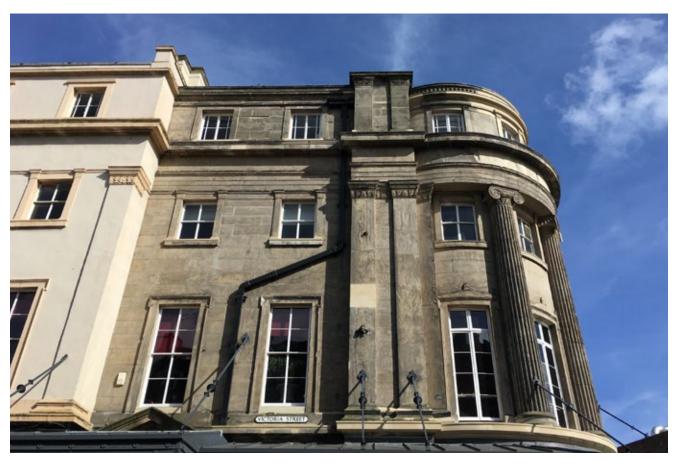
Building frontage after extensive repairs and reinstatement of the missing and decayed stone features and timber sash windows

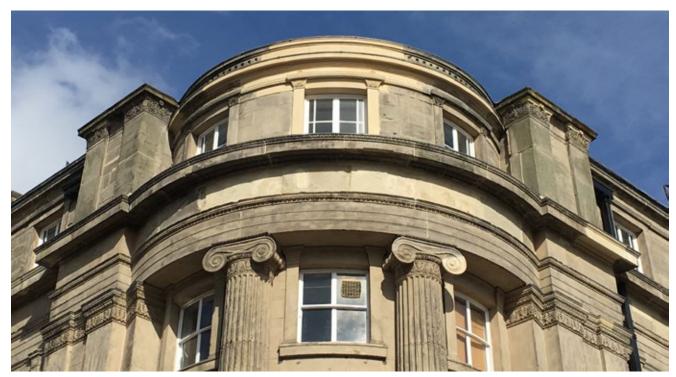
Details of repaired and reinstated curved corner stone features to entablature, pilasters, volute to the capital and repaired windows

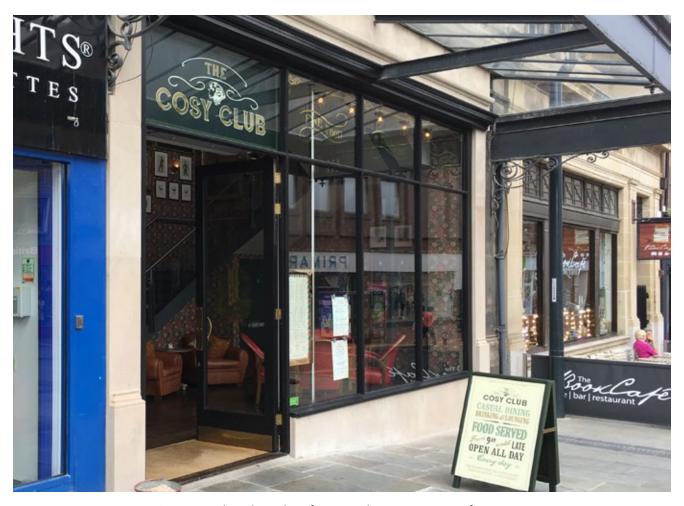
Reinstated timber shopfront and missing stone features.

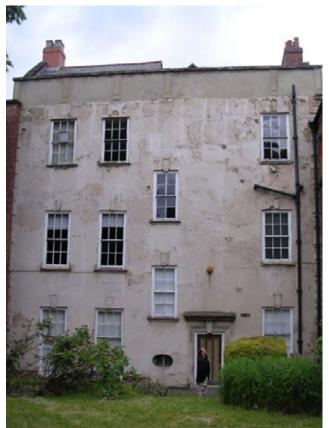
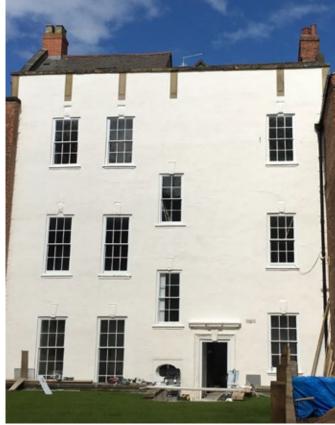
**Heritage Need:** Listed Building in bad state of repairs; leaking roof

and missing historic raingoods; inappropriate cement

Before & After of the rear elevation- Repaired timber sash windows, repaired stone cills and reinstated decayed cills, removal of cement render replaced with lime render, repaired stone parapet and reinstated cast iron rainwater goods.

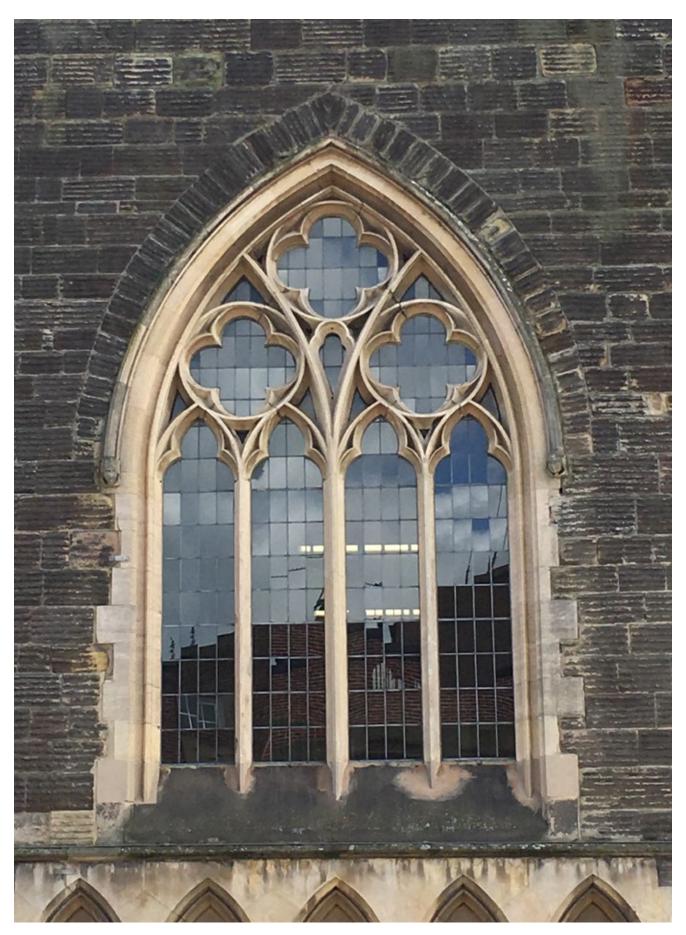
Repaired window stonework

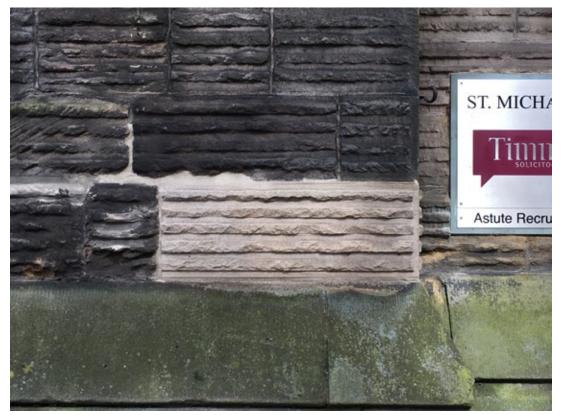
Repaired stonework

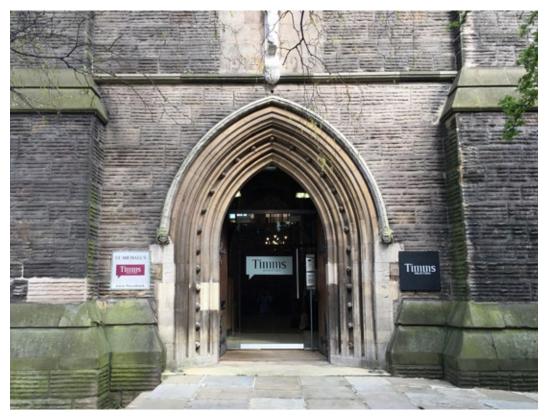
Newly repaired entrance

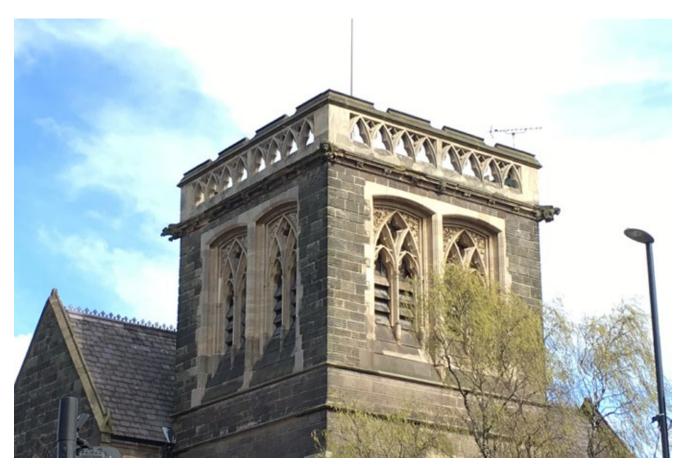
Newly repaired stoneworks to church tower

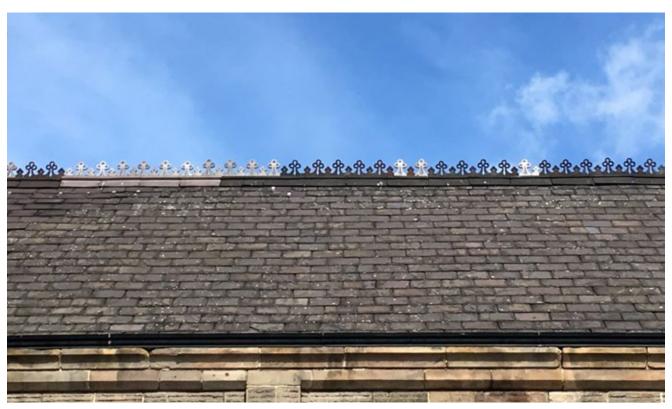
Reinstatement of missing ridge cresting to roof

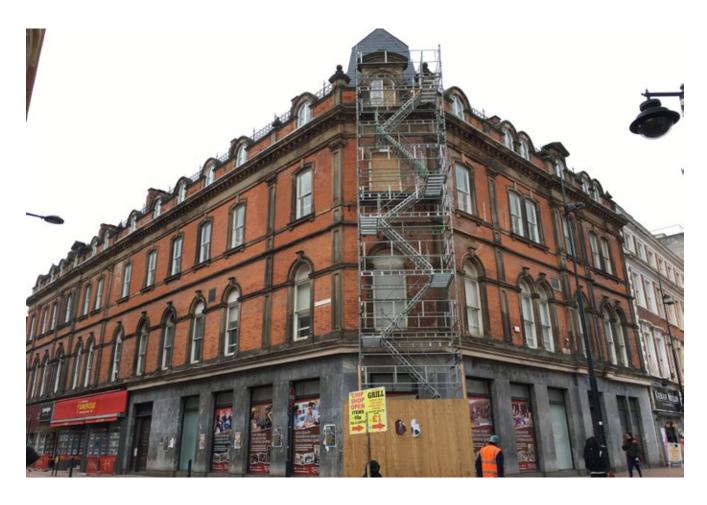
## 1-7 ST. JAMES STREET, DERBY

**Heritage Need:** Windows in bad state of repairs;

Leaking roof cousing damage to fabric

**Scope of work:** Repairs to the building fabric and windows

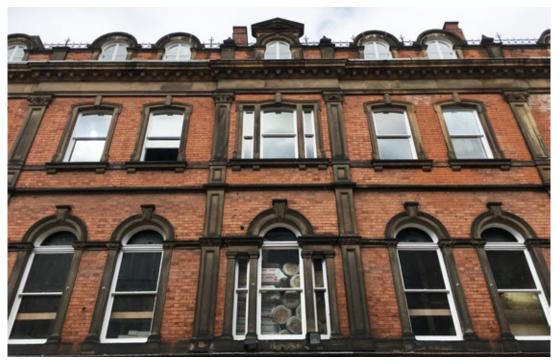
Newly repaired timber windows

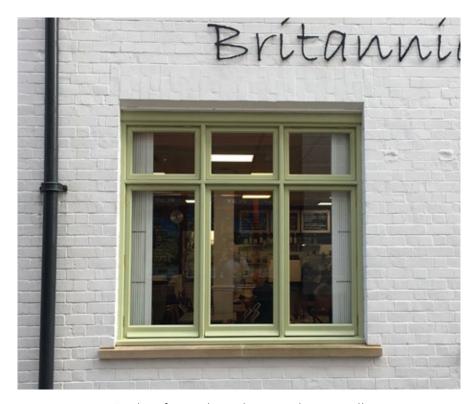
Timber framed windows and stone cill replaced the previous PVC windows

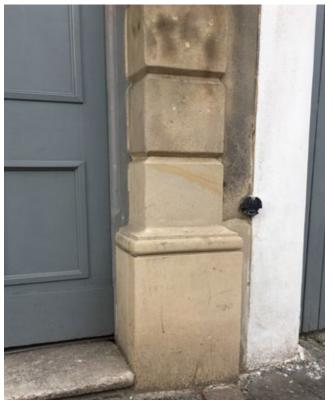
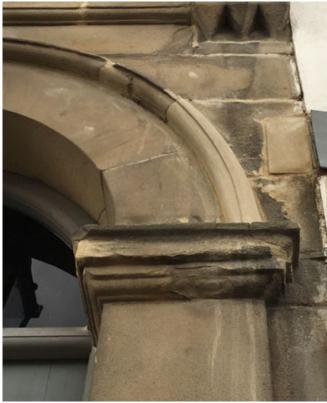
Details of reinstated stone pedestal and decayed stone to column, and missing decorative archway moulding

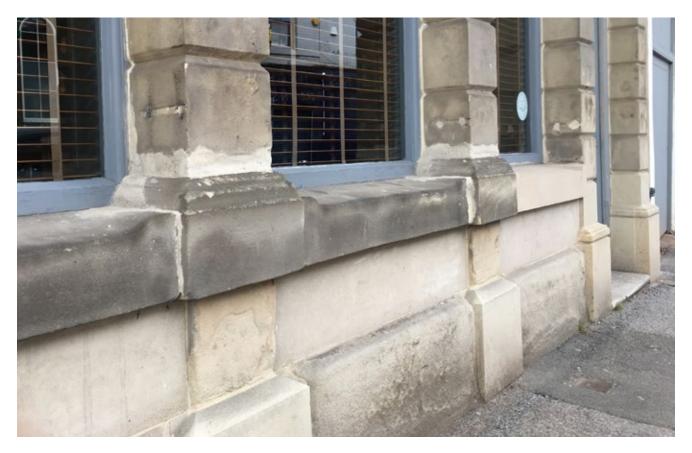
Repaired and reinstated stone facade for pedestal, column and cills
